CLEAR UP CLEAN

Mechanics, when it's time to change the air cleaner element or housing in an M113A2 carrier, don't let your confusion keep the engine from getting the air it needs.

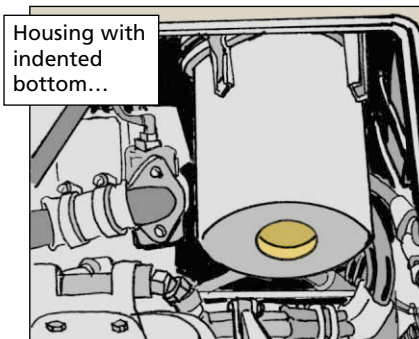
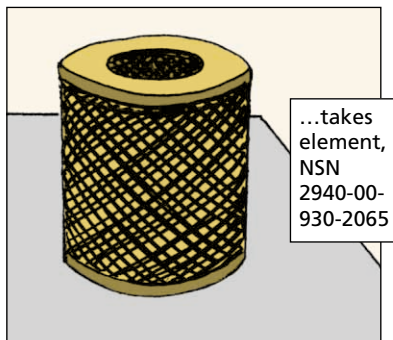
A housing with one circle indented on the bottom is NSN 2940-00-999-2119. The only filter element that works with that housing is NSN 2940-00-930-2065. It has no fins and both ends are open.

There are two different air cleaner elements and housings available. If you match the wrong element to the wrong housing—or vice versa—the carrier's engine will spit, sputter and die because it can't get enough air.

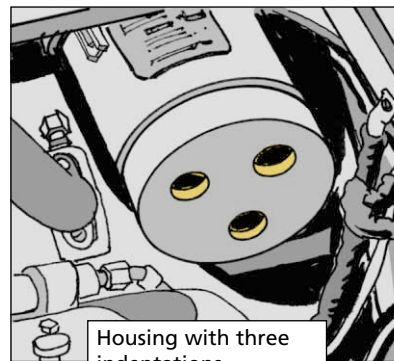
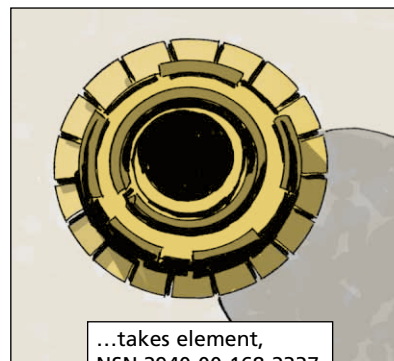
If you've got a housing with three small circles indented on the bottom, it's NSN 2940-00-103-5797. The element for it is NSN 2940-00-168-2337. It has fins at the top and is closed at the bottom.

These elements are not interchangeable. They won't work right unless they're used with their matching housings.

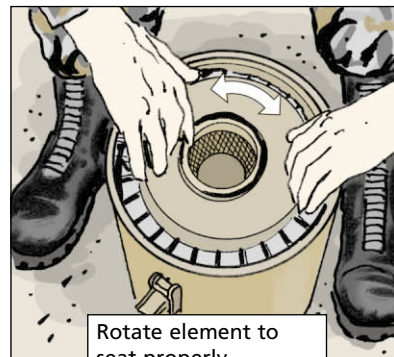
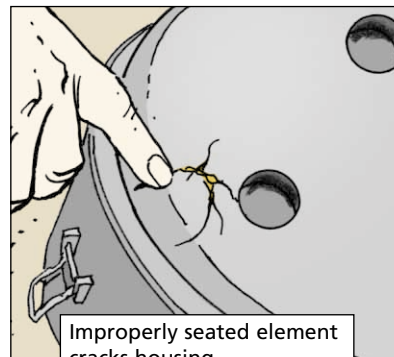
When installing the finned filter element, rotate the element to the left or right after dropping it into the housing. That lets the element drop snugly over the three indented circles at the bottom of the housing.

If you forget, the filter element won't fit right. When you close the clamps, the pressure cracks the housing. That lets dirty air get through—a sure engine killer.

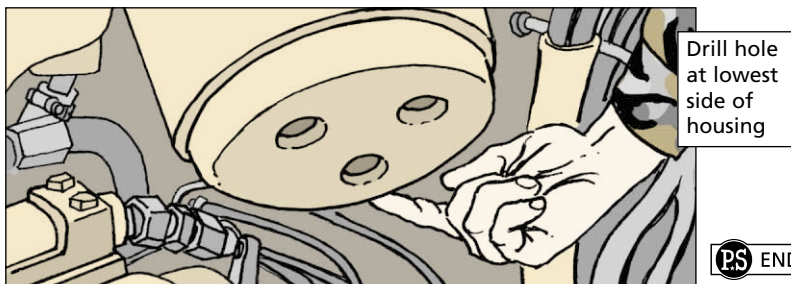
No matter which housing you have, make sure you install it with the drain hole at the lowest point so that water will drain out. No hole? Drill one with a 3/16-in bit.

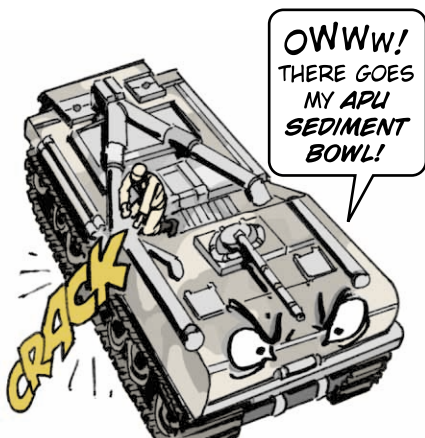
You don't have much room to work on the APU, so it's easy to slip and hit the fuel sediment bowl, especially while you're draining or replacing the fuel filters. Since the sediment bowl, NSN 2910-00-571-5883, is made of glass, it breaks easily.

Watch out for sediment bowl

So save yourself the time and money. Use kid gloves when working on the APU.
